# Final Report

Wisconsin Highway Research Program

Project 0092-02-05

Performance of Shoulders Adjacent to Concrete Pavements

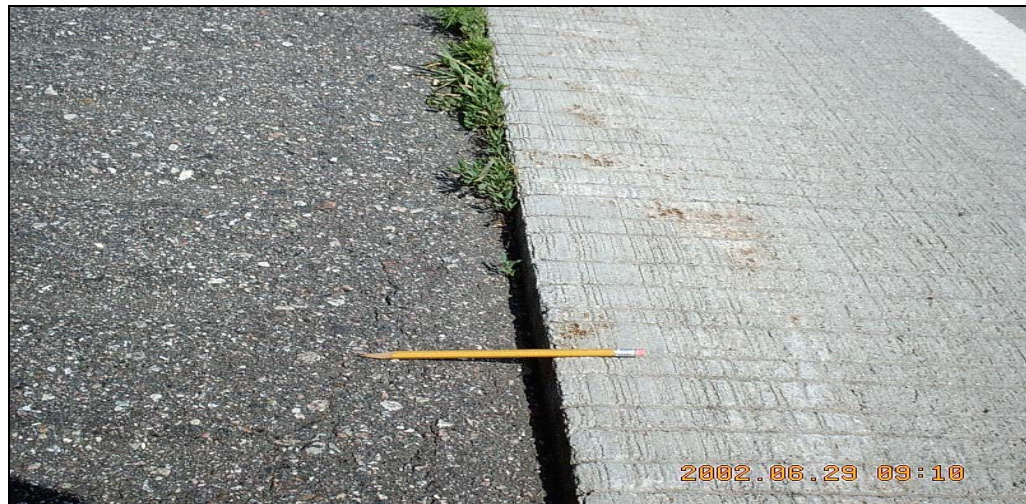
of this composite shoulder on Hwy 29 has no vertical displacement, but has separated horizontally from the PCC slab creating a wide joint opening partially covered with weeds.

**Figure 3.1 An Open Joint Partially Covered with Weeds**

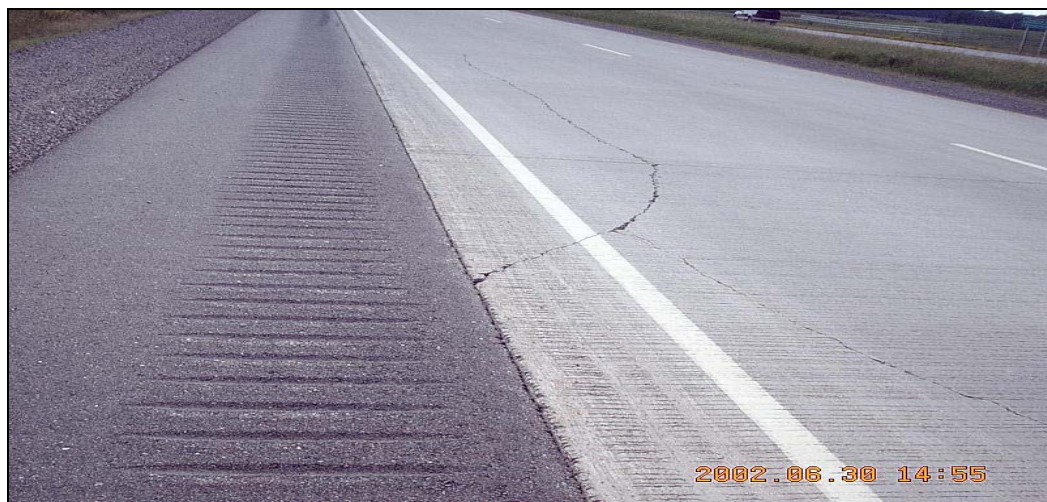
- b) Distresses on the PCC portion of a composite shoulder were observed to be a progression from the mainline (see Figure 3.2). In this instance, only general observations were made in the field and documented. No formal measurements were taken on the PCC portion of the composite shoulder. All effort was concentrated on the joint and the adjacent AC component. Figure 3.2 shows a composite shoulder with a slab breakup on the PCC portion of the shoulder. The breakup appears to be the result of the fracture that has occurred within the entire slab.

**Figure 3.2 Composite Shoulder Distress – Migrating Longitudinal Crack**

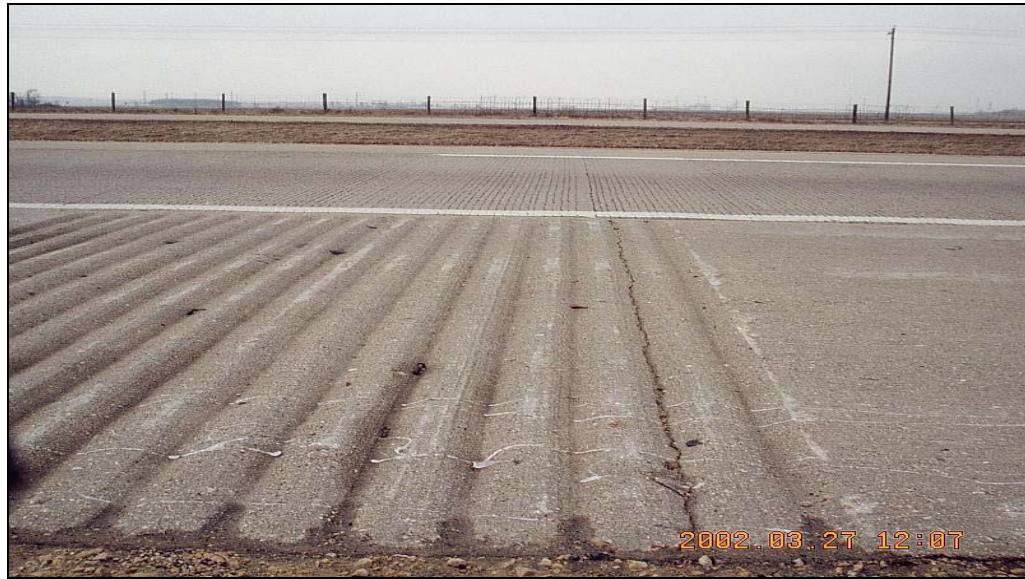
c) The majority of slab breakup in concrete shoulders involved the grooves of rumble strips (see Figure 3.3). A combination of reduced thickness and localized depression has provided an opportunity for crack propagation.

**Figure 3.3 Concrete Shoulder Fracture in Groove of Rumble Strip**

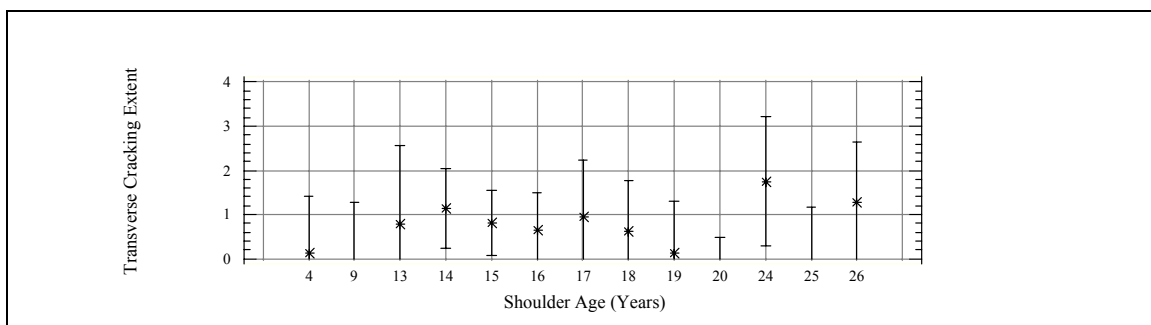
**Figure 4.109 Transverse Cracking Extent and Age (Non-Composite Type-5)**

Shoulder base thickness, SSV, PCC thickness, functional class, and age affected transverse cracking. Key findings were an increase in the mean level of extent with an increase in base thickness (Figures 4.101 and 4.102). A general reduction in severity level was observed with an increase in SSV (Figure 4.103). There was also a general reduction in extent and severity with increasing PCC thickness (Figures 4.104 through 4.106). Traffic, as measured by the roadway functional classification, had a higher severity level for Interstate and U.S. Highways (Figures 4.1107 and 4.108). An increase in age produced random variation in the mean level, with a slight increase in the extent (Figures 4.109 and 4.110).

Distress (1)	INFLUENTIAL VARIABLE (S) (2)	ISSUES FOR MAINTENANCE CONSIDERATIONS (3)	REFERENCE* (4)
Transverse Cracking	Functional Class	The combination of extent and severity is worse on Interstate highways	Figure 4.108
	Age	The extent increases with age.	Figure 4.109
Longitudinal Cracking	Longitudinal joint filling	The combination of extent and severity is better when longitudinal joint is not filled	Figure 4.120
Outside Edge Raveling	Age	The severity (also denoted by the index) worsens with age	Figures 4.127 & 4.128
Heave	Age	The combination of extent and severity worsens with age.	Figure 4.134
Settlement	Functional Class	Extent is higher for Interstate highways	Figure 4.142
	Age	Extent increases with age.	Figure 4.143
Longitudinal Joint Deterioration	-	-	-
* Table 4.17 for all parameters

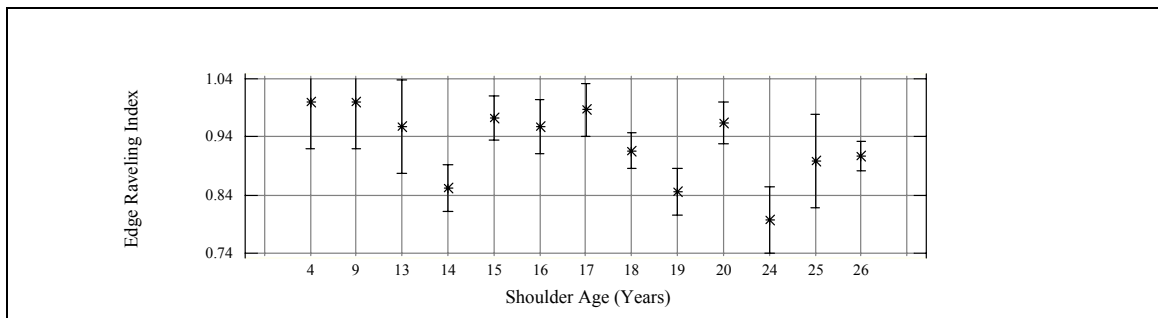
**Figure 4.128 Edge Raveling Severity and Age (Non-Composite Type-5)**

Four design variables affected edge raveling: shoulder width, shoulder thickness, SSV, and edge drain. Shoulder width produced a lower severity with increasing width (Figures 4.121 and 4.122). The severity of edge raveling was reduced with a thicker shoulder surface of 4 inches (Figures 4.123 and 4.124). SSV had a positive effect where an increasing value decreased the severity level (Figures 4.125 and 4.126). A random variation in severity mean levels occurred with increasing age (Figures 4.127 and 4.128).

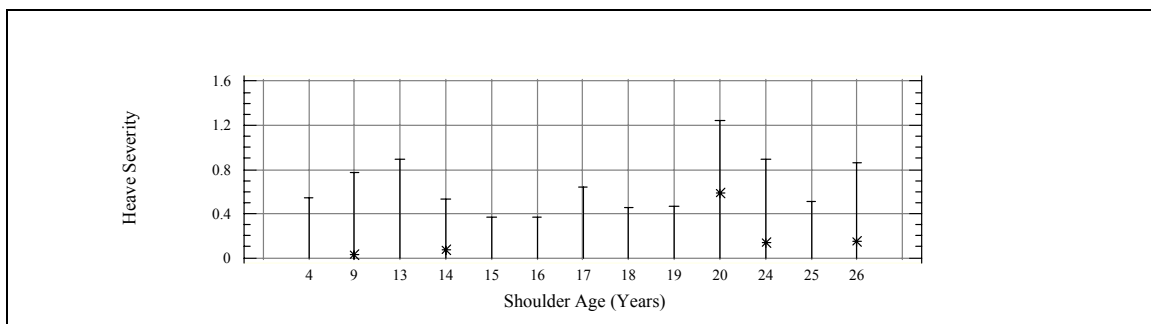
**Figure 4.133 Heave Severity and Age (Non-Composite Type-5)**

Heaving had a significant relationship with shoulder base thickness and age. The mean level for extent and severity was substantially higher for the 8-inch thick shoulder base, however, the other thickness values had similar means levels (Figures 129 through 131). Figures 4.132 through 4.134 show a gradual increase in extent and severity with age.

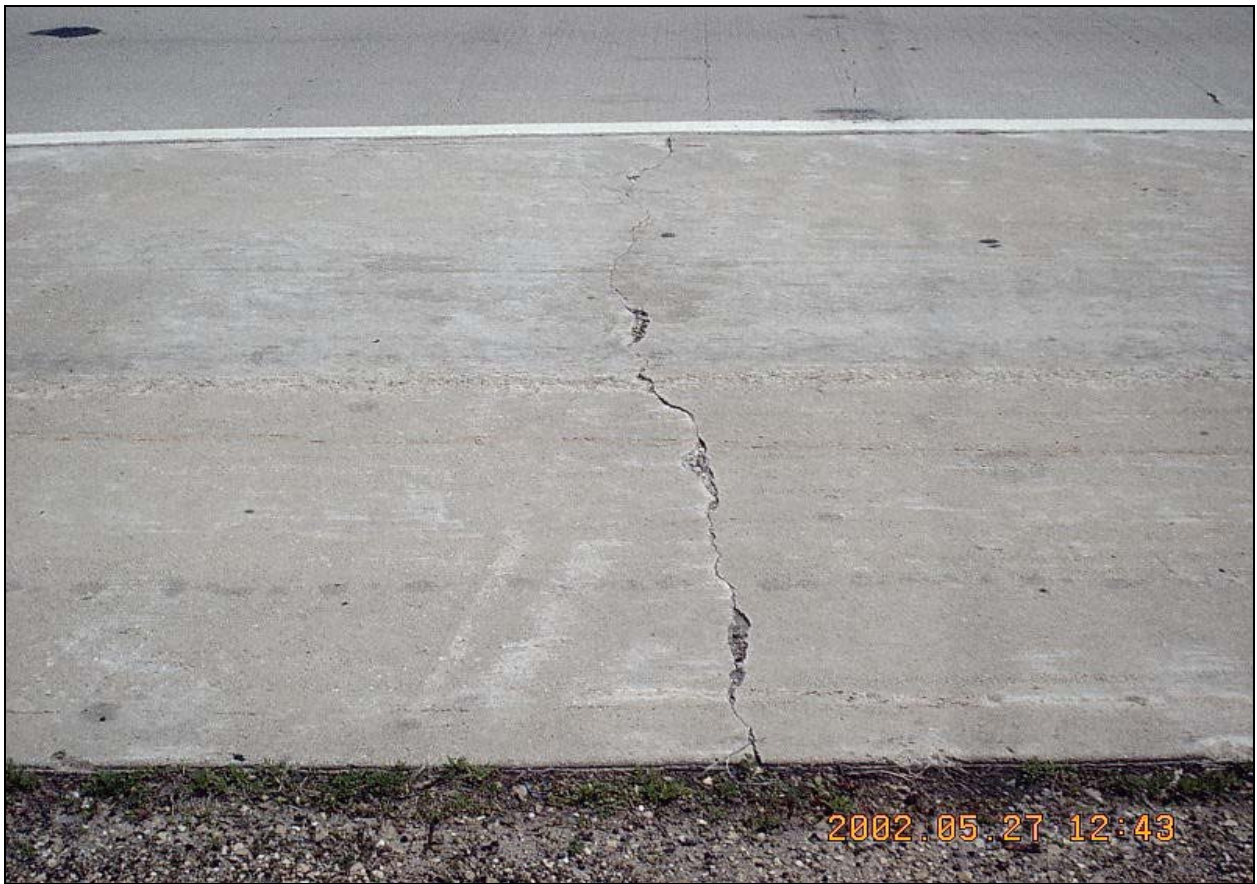
**Figure F-1 Distress Joint/Crack Severity Level 1**

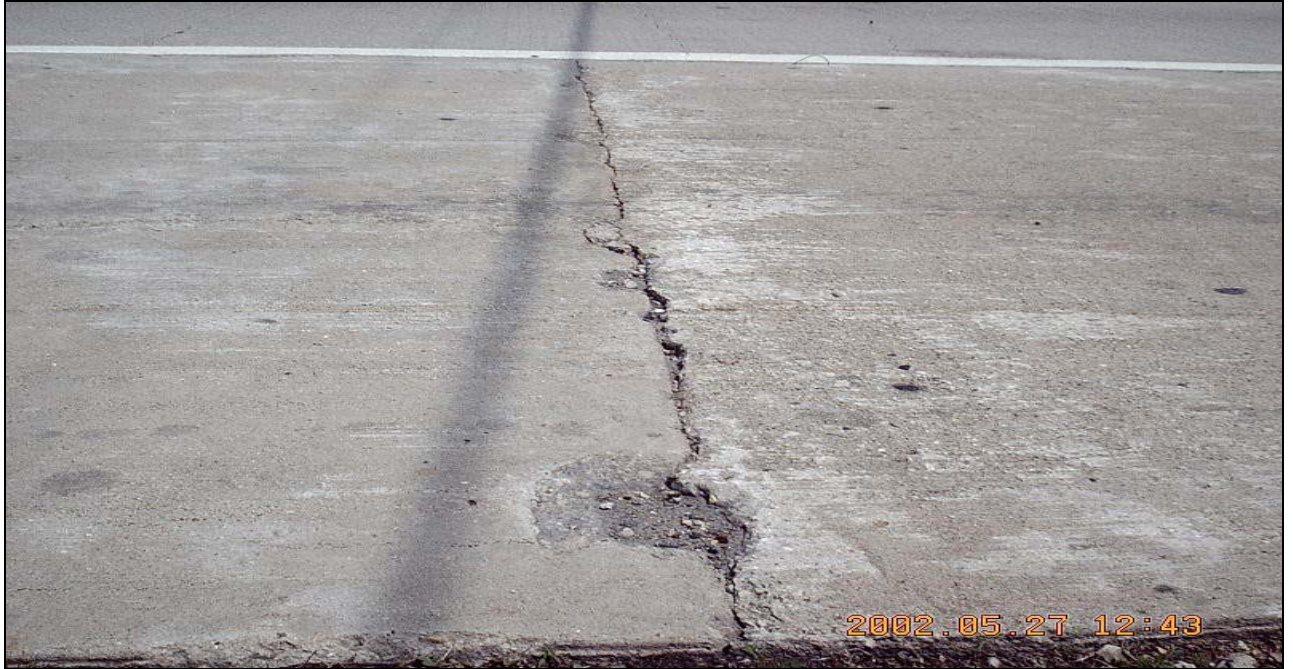
**Figure F-2 Distressed Joint/Crack Severity Level 2**

*[Note that crack shows spalling, moderate loss of pavement, and general surface deterioration in the immediate vicinity of the crack]*

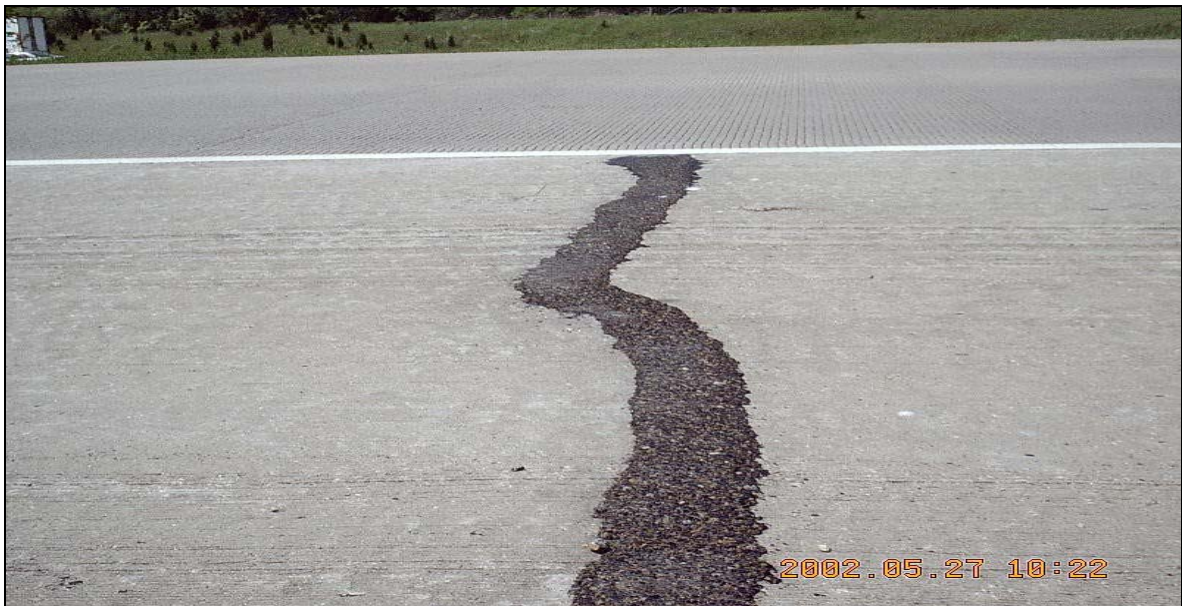
**Figure F-3 Distressed Joint/Crack Severity Level 2**

*[Note the wide patch was probably due to moderate spalling of crack edges and significant loss of pavement material in the immediate vicinity of the crack]*

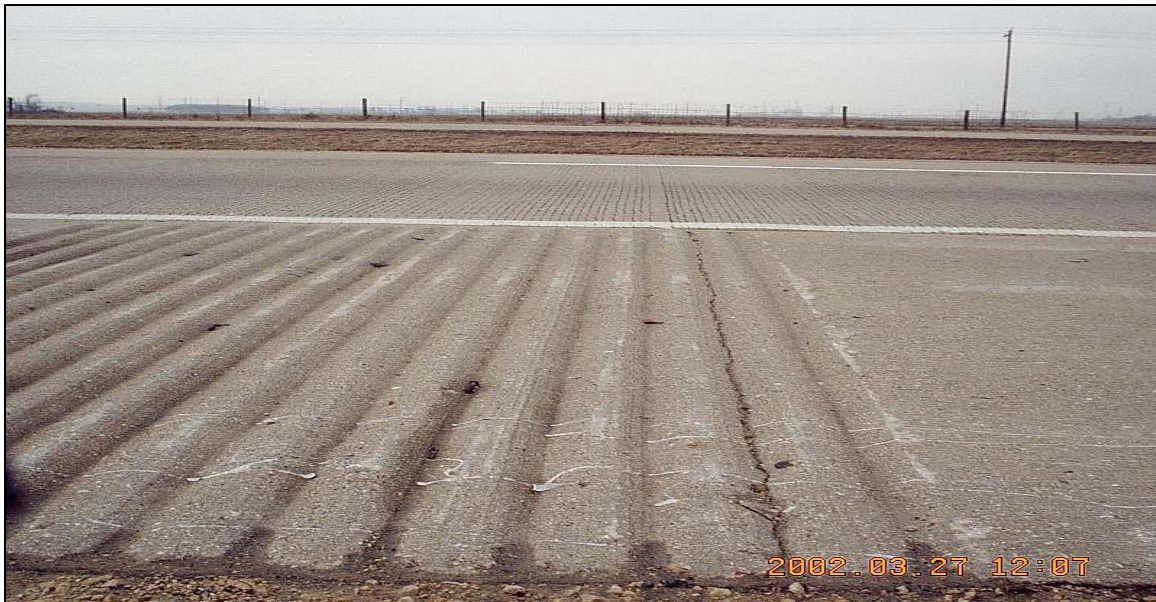
**Figure F-4 Slab Breakup Severity Level 1**

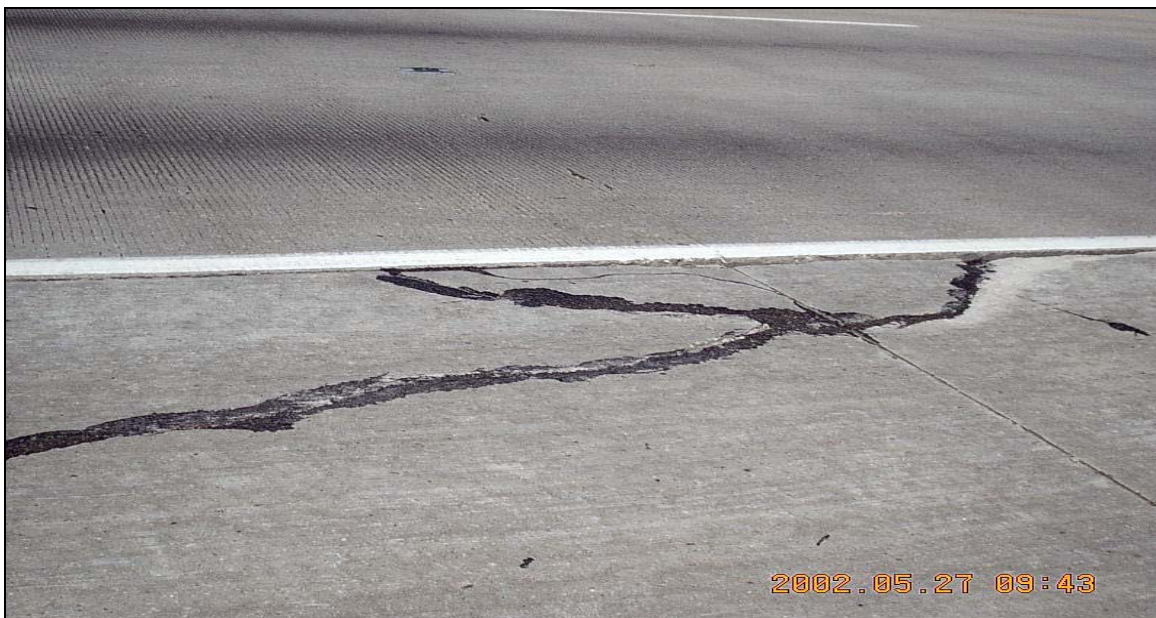
**Figure F-5 Slab Breakup Severity Level 1**

*[Slab is broken up by two cracks; notice that cracks have been sealed, but not adequately]*

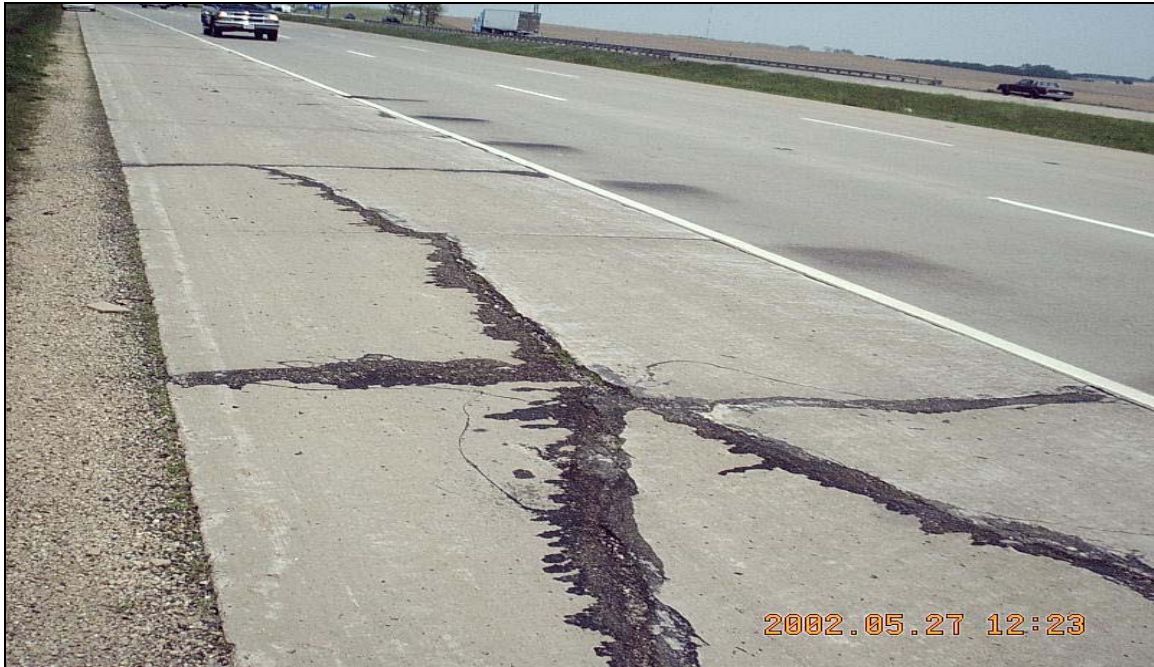
**Figure F-6 Slab Breakup Severity Level 2**

*[Slab is broken up into five parts by interconnecting cracks, which have been sealed]*

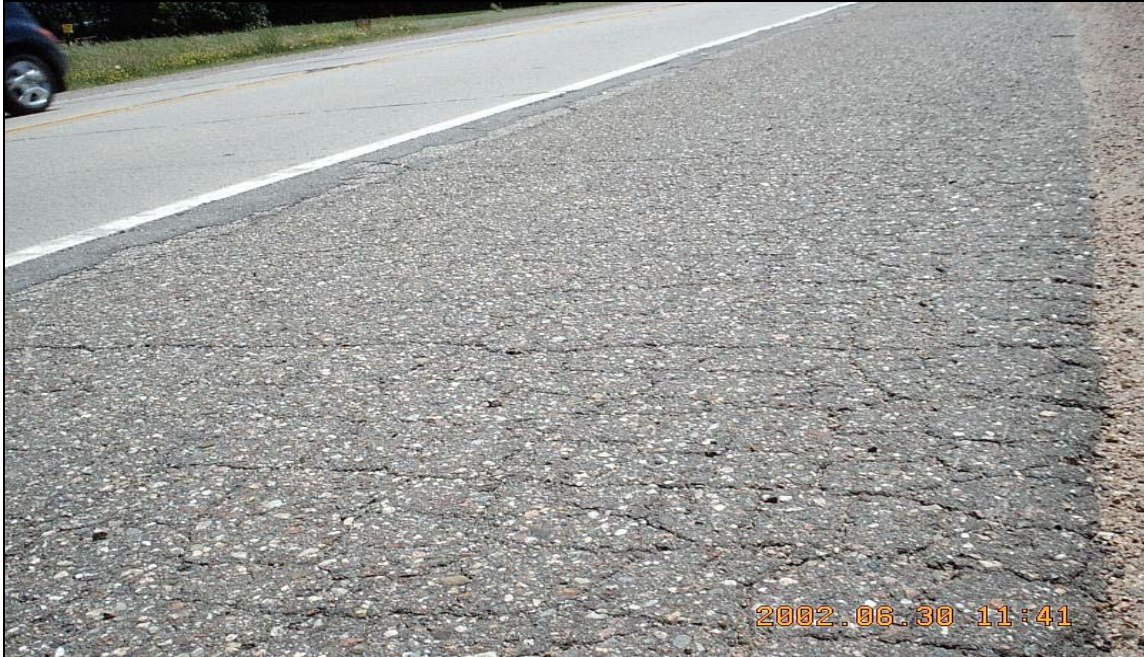
**Figure G-1 Alligator Cracking Severity Level 1**

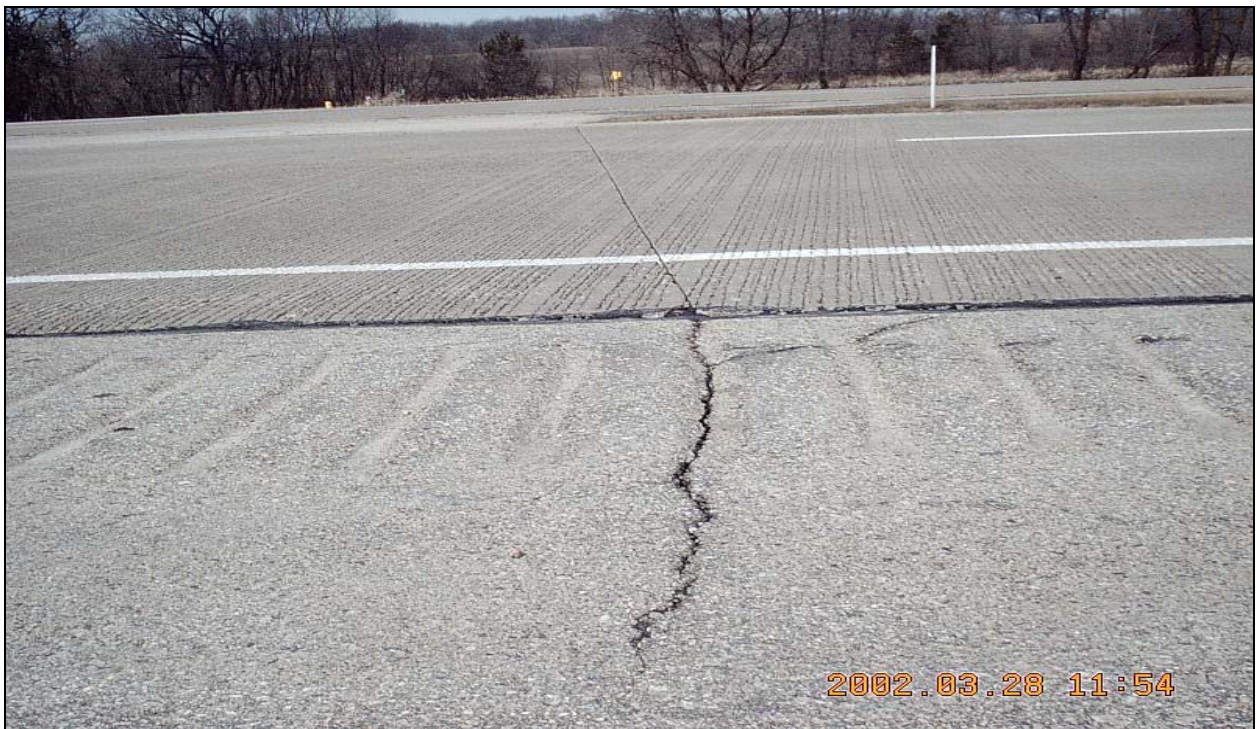
**Figure G-2 Transverse Cracking Severity Level 1**

*[This is a "sympathetic" transverse cracking developed as a continuation of the PCC joint from the mainline. Crack width is less than 1/2-inch with slight spalling at the edges]*

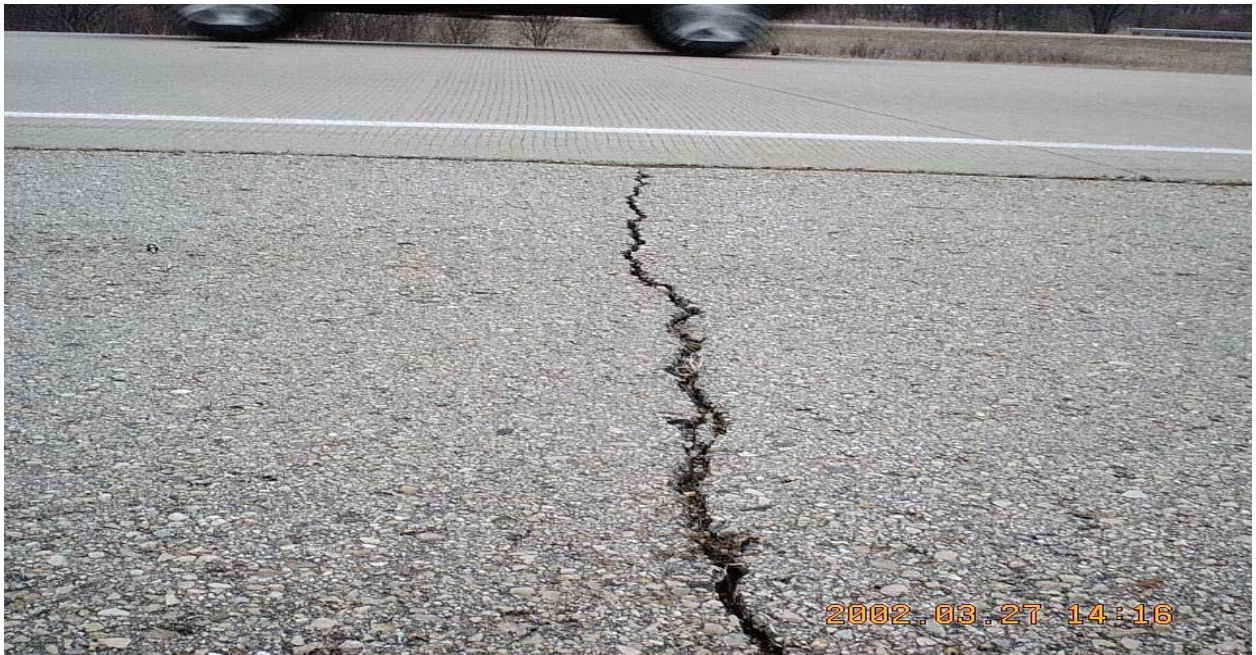
**Figure G-3 Transverse Cracking Severity Level 2**  
[Crack width is greater than 1/2-inch and exhibits some spalling at the edges]

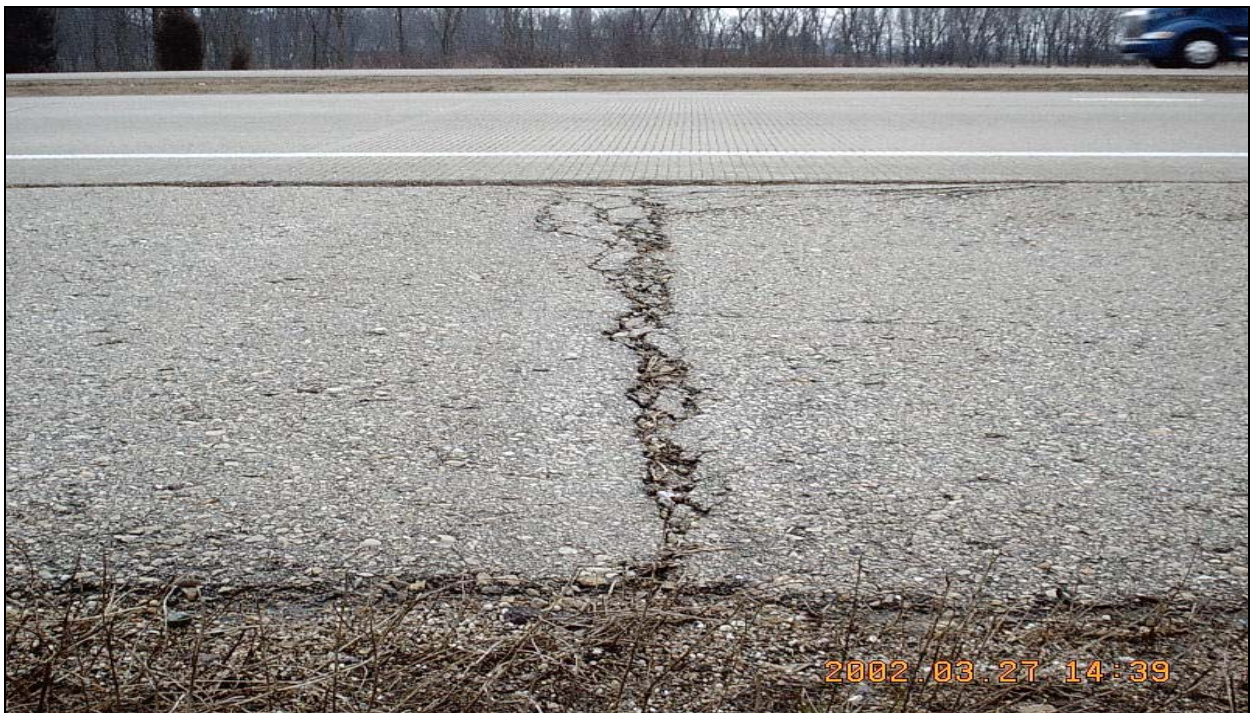
**Figure G-4 Transverse Cracking Severity Level 3**  
[Notice that there is some dislodgement of pavement material and band cracking also appear close to the longitudinal joint]

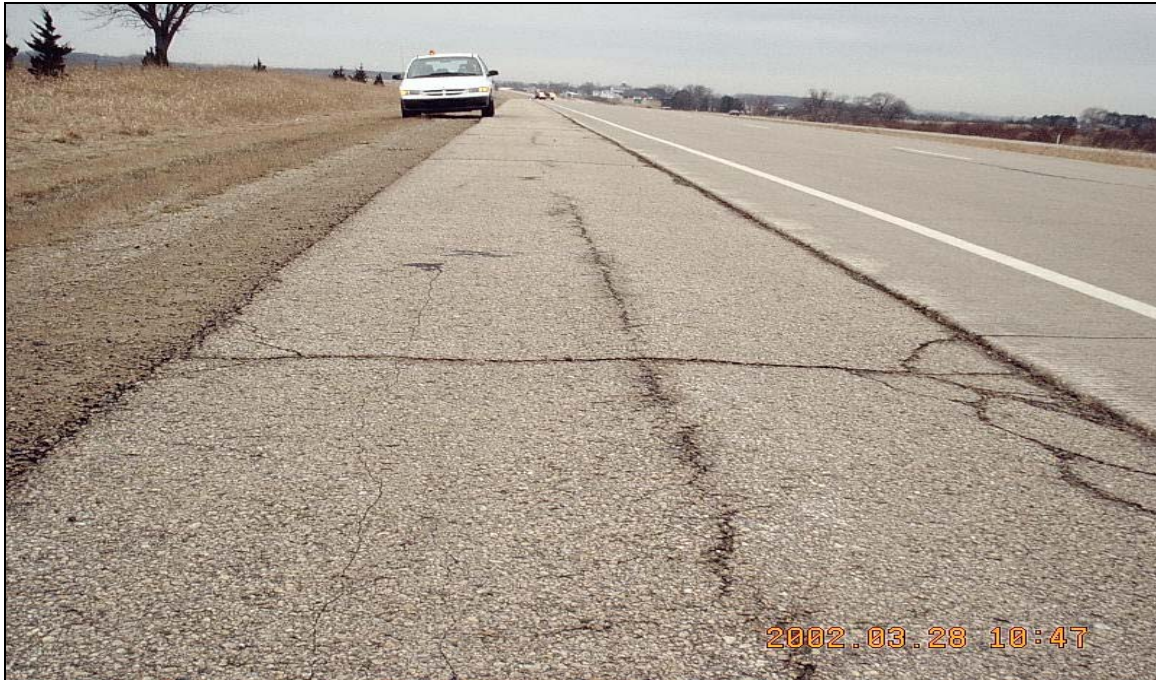
**Figure G-5 Longitudinal Cracking Severity Level 2**  
[Crack width is greater than ½-inch]

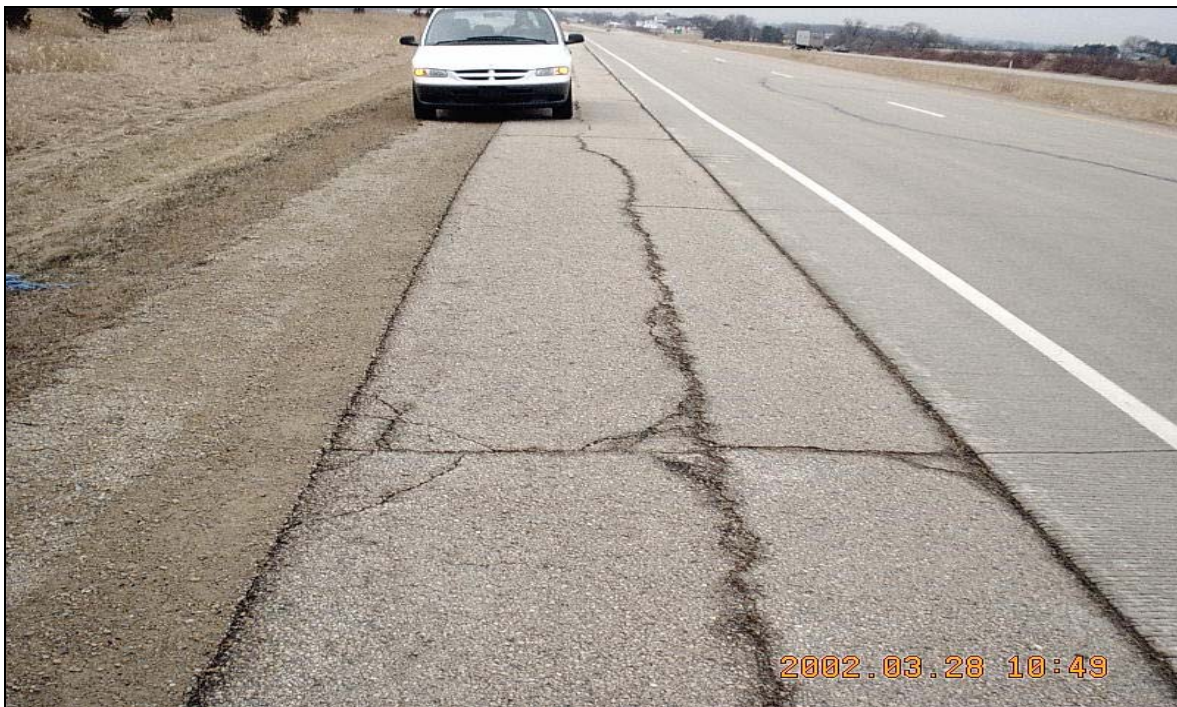
**Figure G-6 Longitudinal Cracking Severity Level 3**  
[Some dislodgment of pavement and band cracking at intersection of transverse crack].

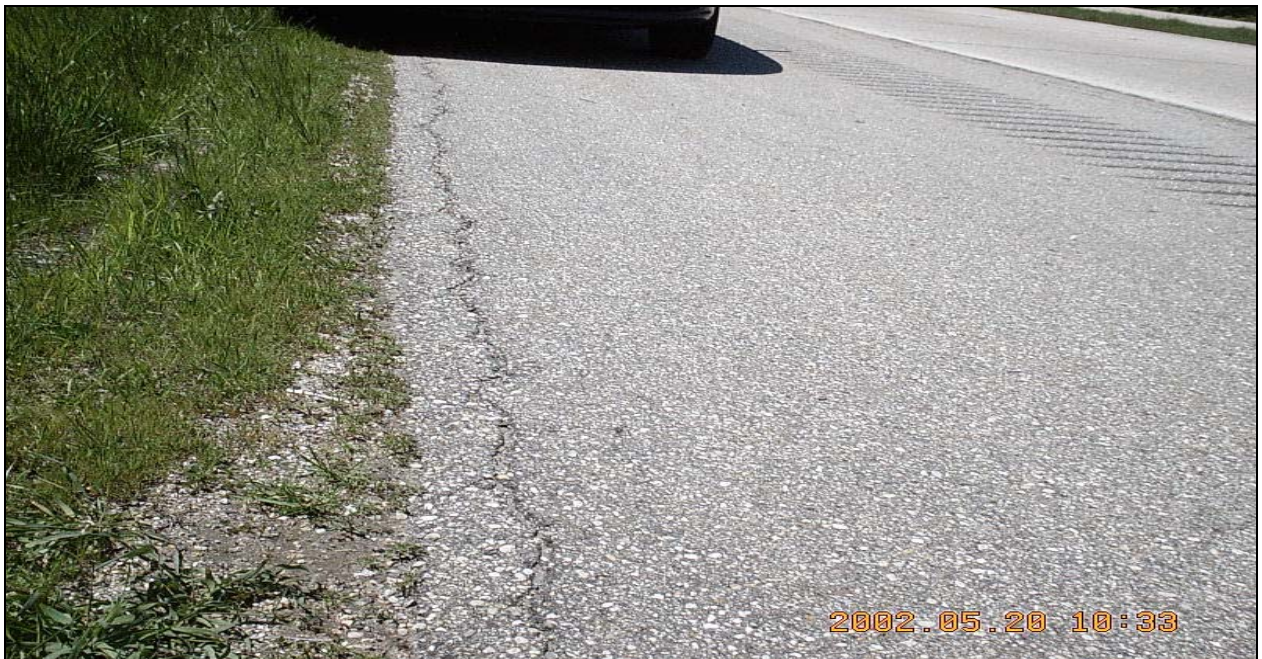
**Figure G-7 Edge Raveling Severity Level 1**

*[Cracking has occurred at the edge but pavement is still intact].*

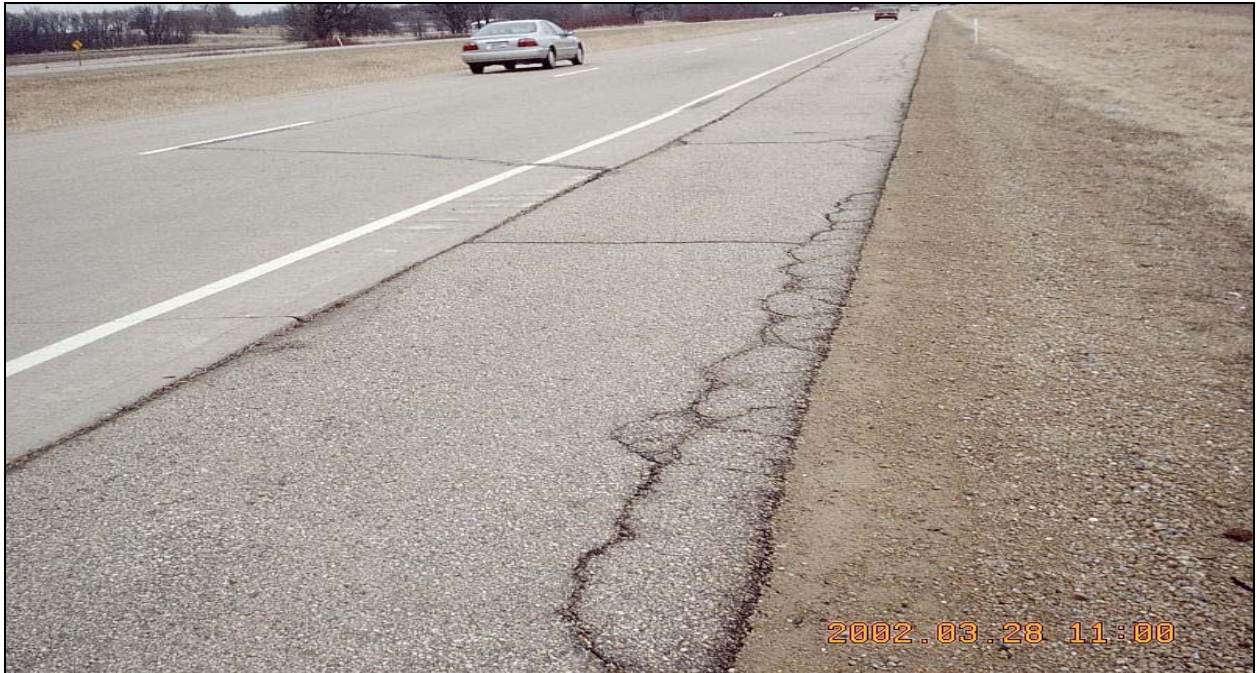
**Figure G-8 Edge Raveling Severity Level 2**  
*[Some evidence of pavement dislodgement exists at the edge]*

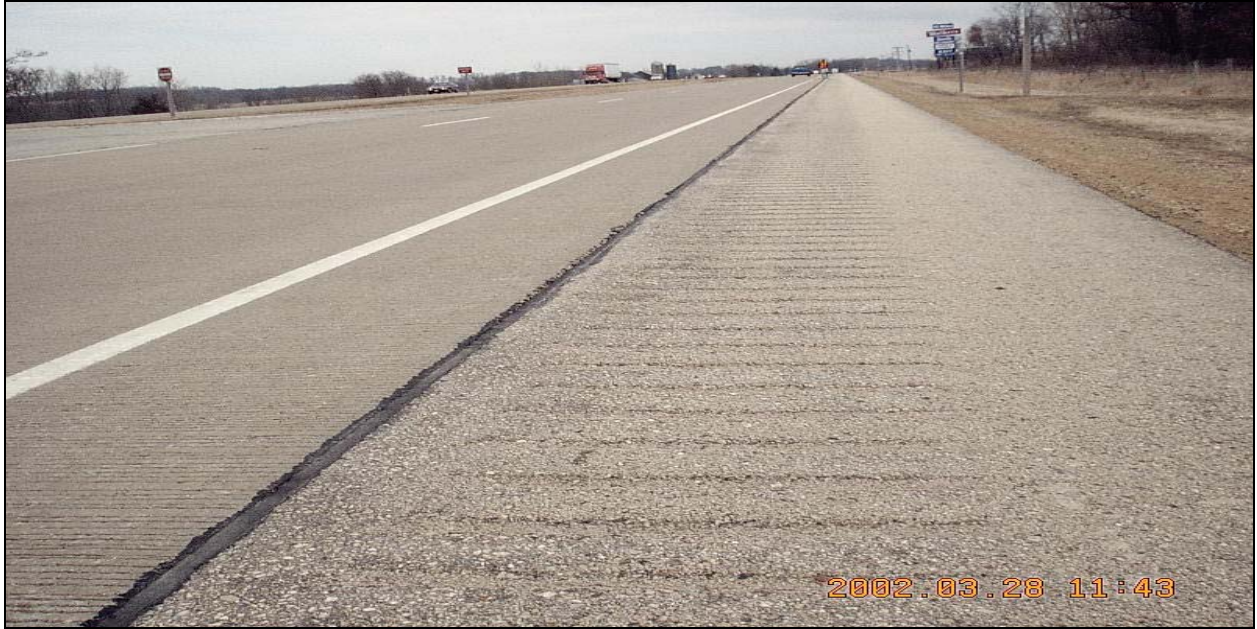
**Figure G-9 Longitudinal Joint Deterioration Severity Level 0**

*[Joint is completely sealed and there are no distresses within 2 feet of the joint on the shoulder side of the joint]*

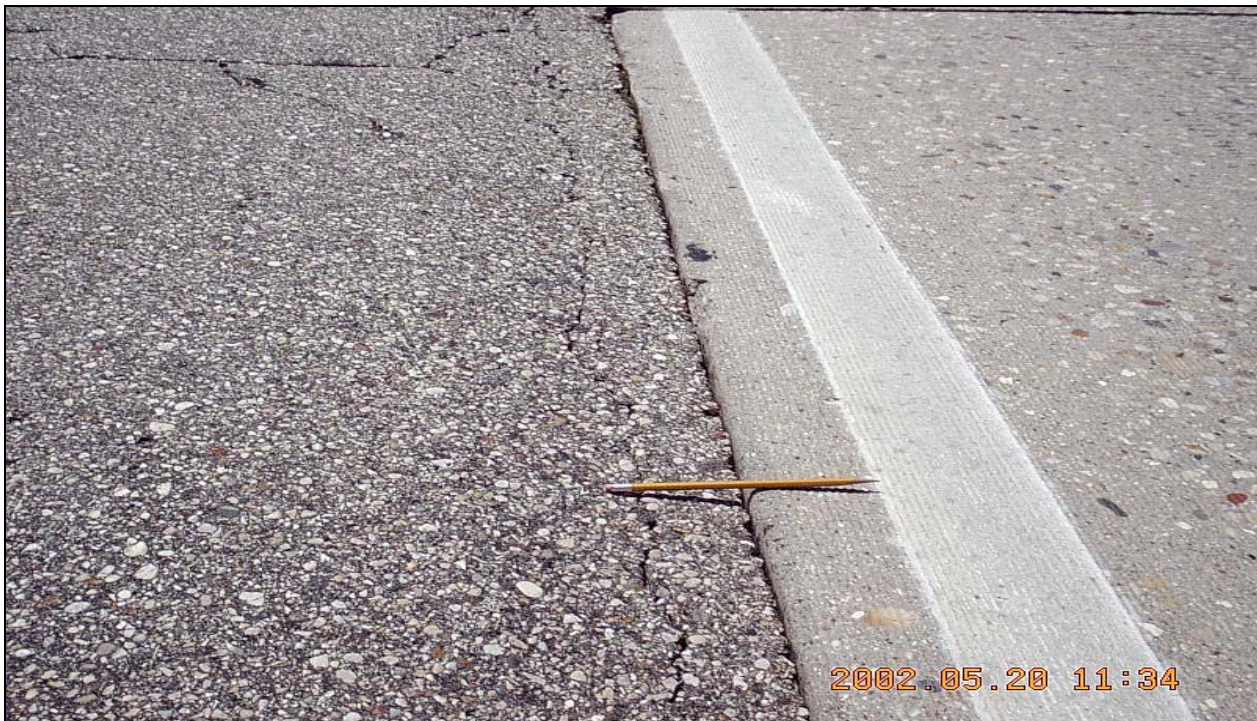
**Figure G-10 Longitudinal Joint Deterioration Severity Level 1**

*[Joint opening is less than 1/2-inch and low severity level cracking exists within two feet of the joint on the shoulder side of the joint. The surface also appears slightly weathered]*

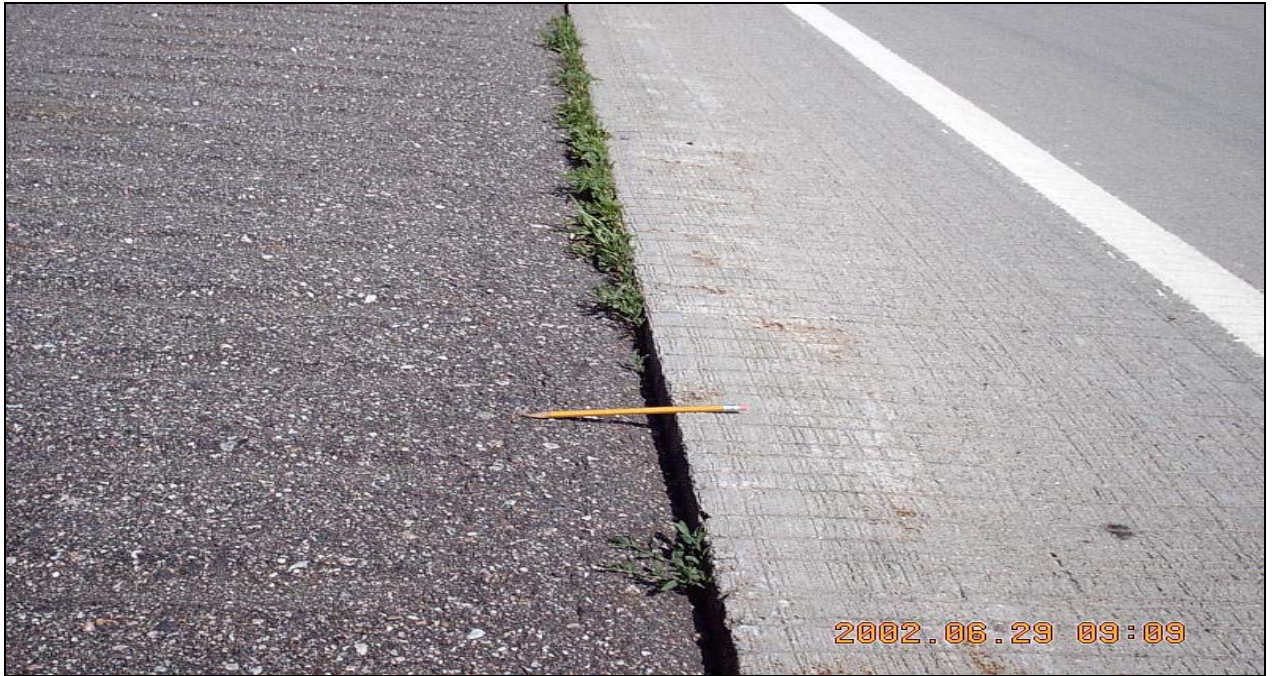
**Figure G-11 Longitudinal Joint Deterioration Severity Level 1**  
[Note that joint opening is filled with weeds and surface appears slightly weathered]

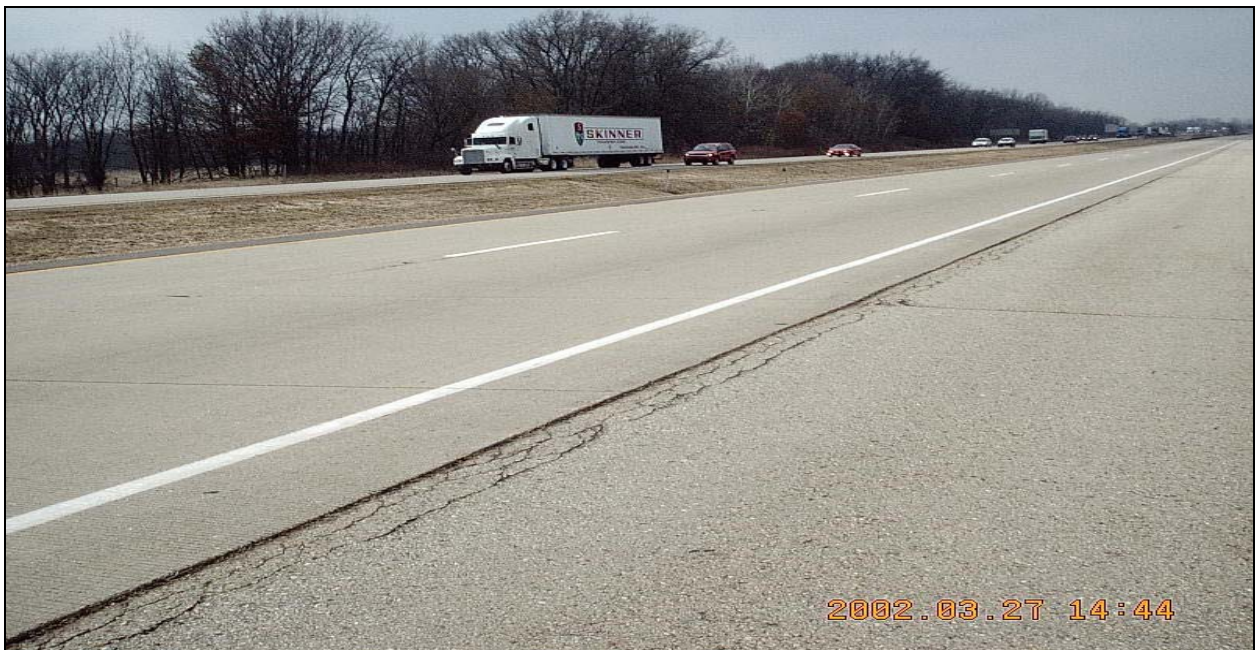
**Figure G-12 Longitudinal Joint Deterioration Severity Level 2**  
[Bands in the form of alligator cracking appear here and seem to be the effect of encroaching traffic]

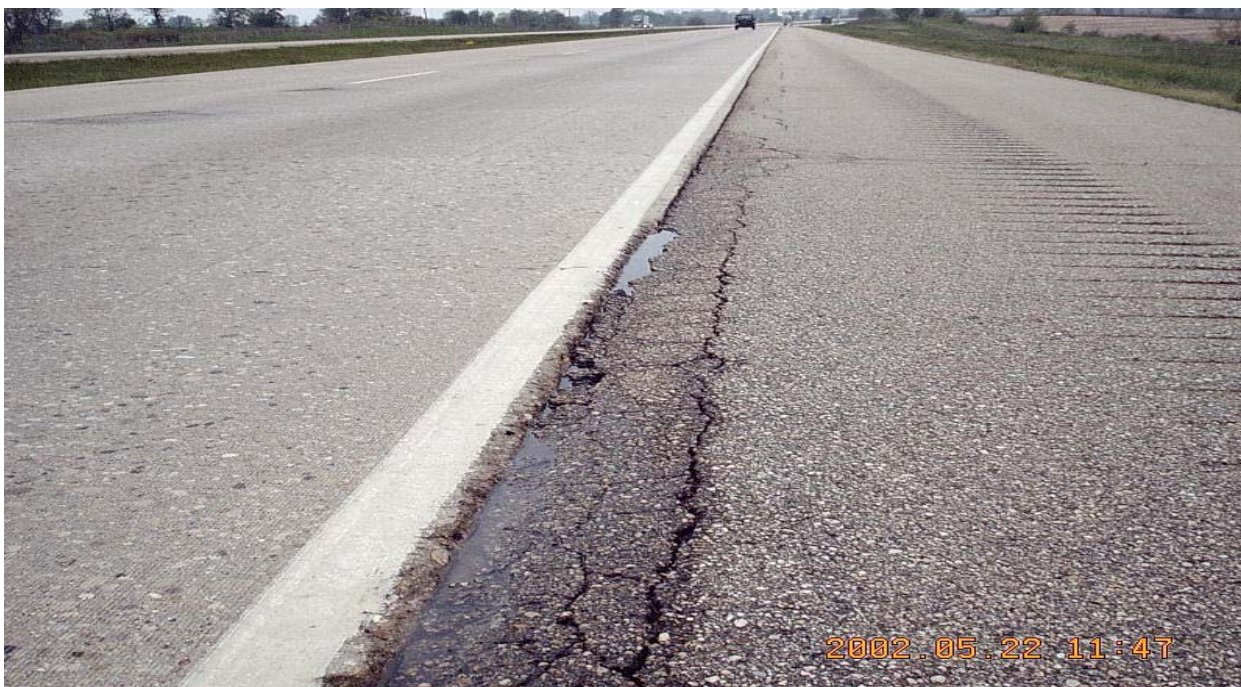
**Figure G-13 Longitudinal Joint Deterioration Severity Level 3**

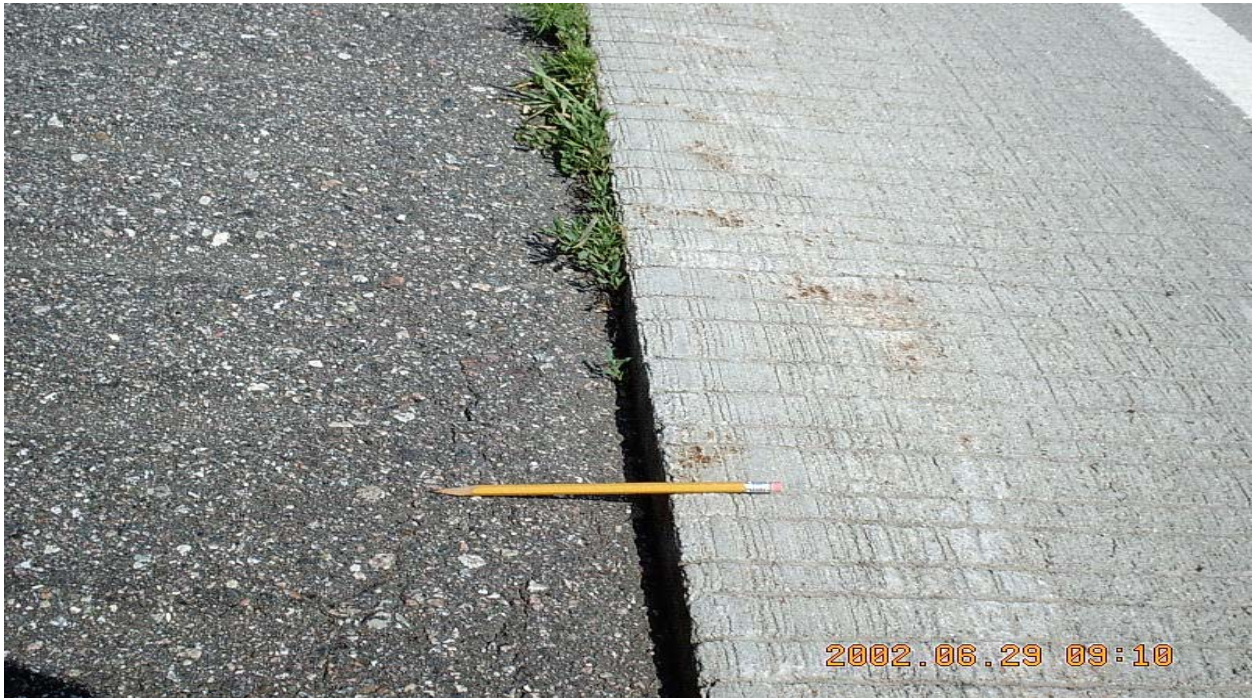
**Figure G-14 Shoulder Settlement Severity Level 0**

*[There is a horizontal separation here but no vertical separation or settlement.]*

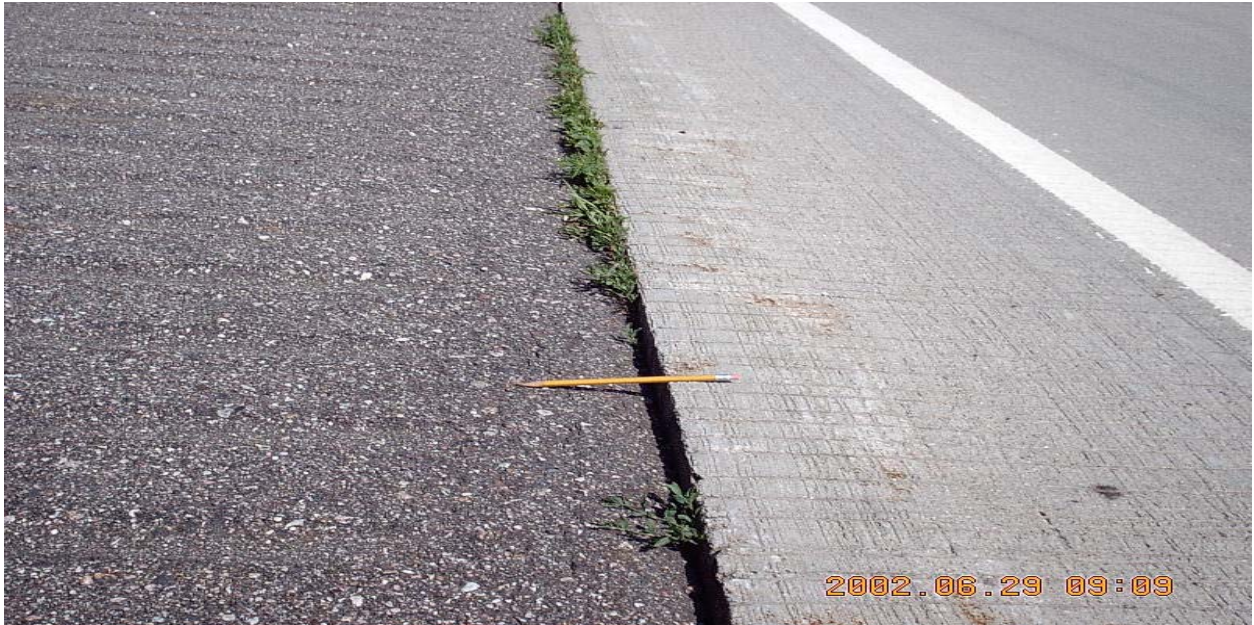
**Figure G-15 Shoulder Settlement Severity Level 1**

*[The AC shoulder component of this composite shoulder is at a slightly lower elevation than the PCC slab. The slope of the pencil shows this. The measured average settlement was less than ½-inch]*

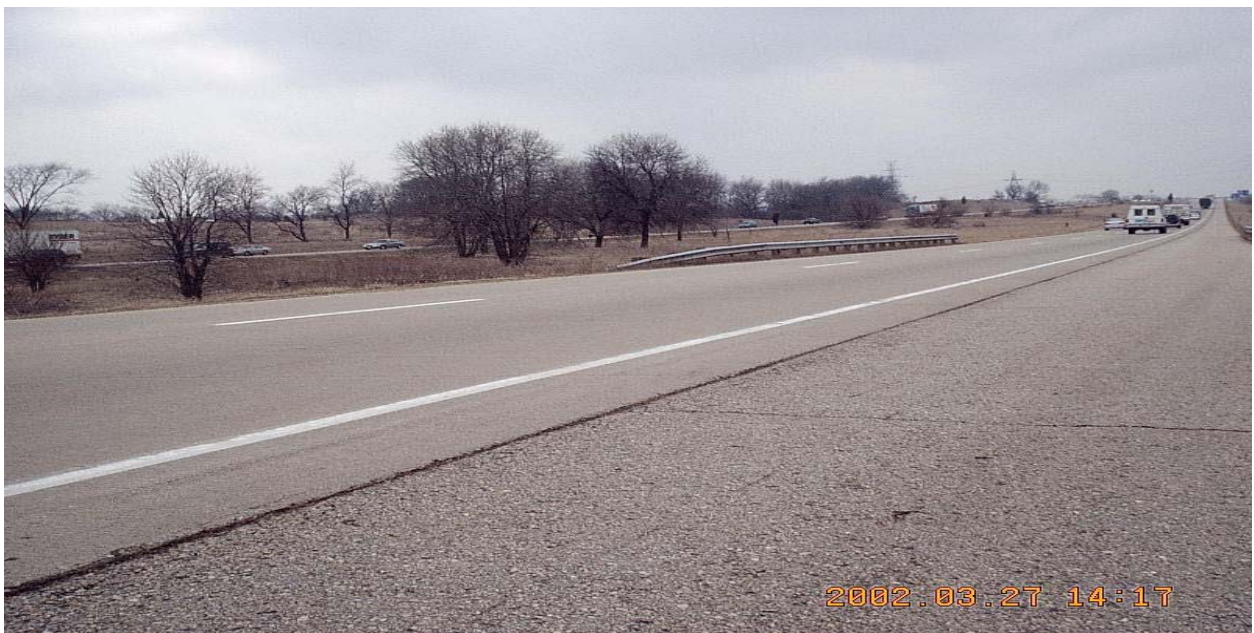
**Figure G-16 Shoulder Settlement Severity Level 2**

*[The AC shoulder component of this composite shoulder is at a lower elevation than the PCC slab. The measured average settlement was between ½ and 1-inch]*
